## BAGGALEY DAM

YOUNGSTOWN BOROUGH MUNICIPAL AUTHORITY

### PHASE I INSPECTION REPORT NATIONAL DAM INSPECTION PROGRAM

MAY 1980

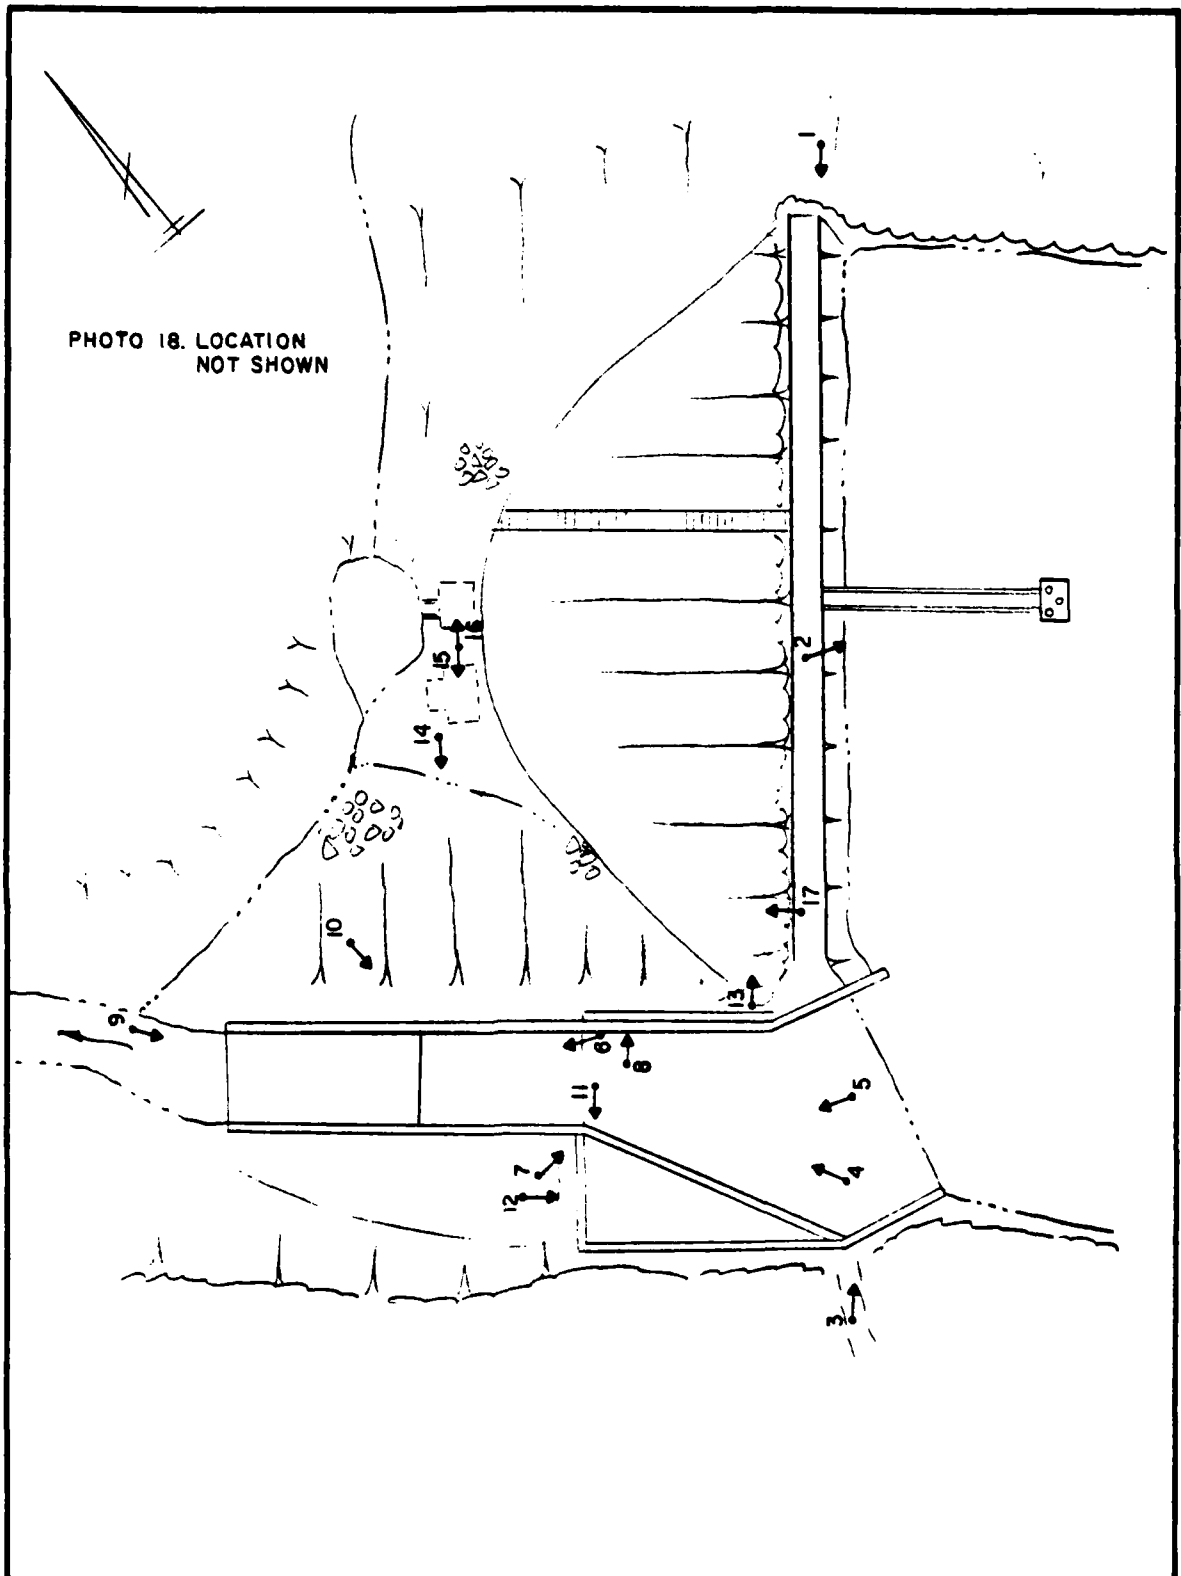
PHOTO 18. LOCATION  
NOT SHOWN

PHOTO 18 DOWNSTREAM DEVELOPMENT

- Photo 14- Flowing Water at Embankment Toe. Sources of water are springs located in the left groin of the embankment.
- Photo 15 - Abandoned Foundation (left) at embankment toe. Water surface is two feet below ground surface.
- Photo 16 - Abandoned Foundation (right). Note absence of water. Left and right foundations are ten feet apart.
- Photo 17 - Downstream Channel as seen from spillway chute crest. Note flow channel from embankment toe area.
- Photo 18 - Downstream Development with Indian Camp Run visible behind dwelling.
